Chapter 12

Environmental monitoring: inspection, investigative monitoring techniques for historic buildings and case studies - brief paper

Huw Lloyd, technical director, Dr Jagjit Singh, director, Environmental Building Solutions Ltd, UK

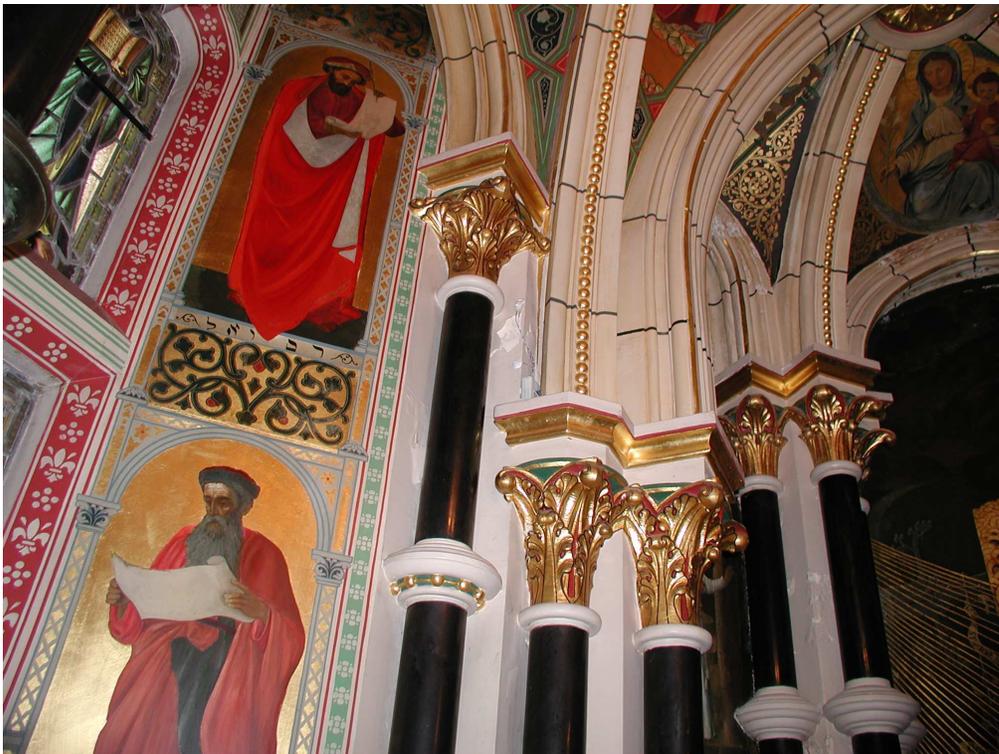
Photograph 1 Decorative finishes in Cardiff Castle

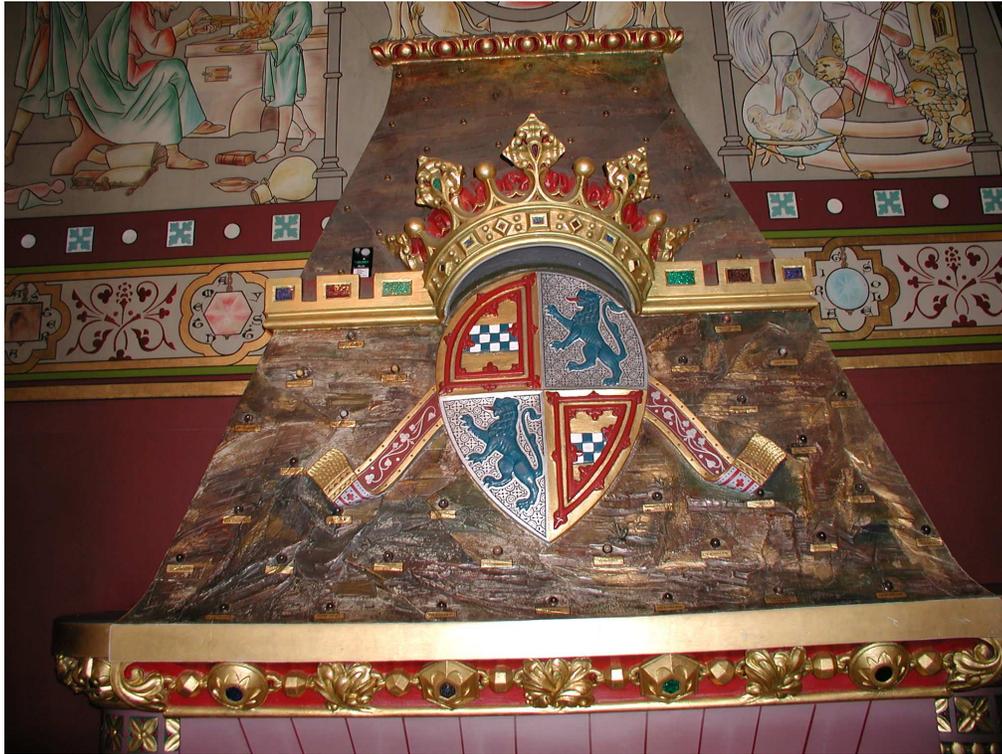
Photograph 2 Showing UV/Lux data logger for the measurement of measurement UV and Lux levels.

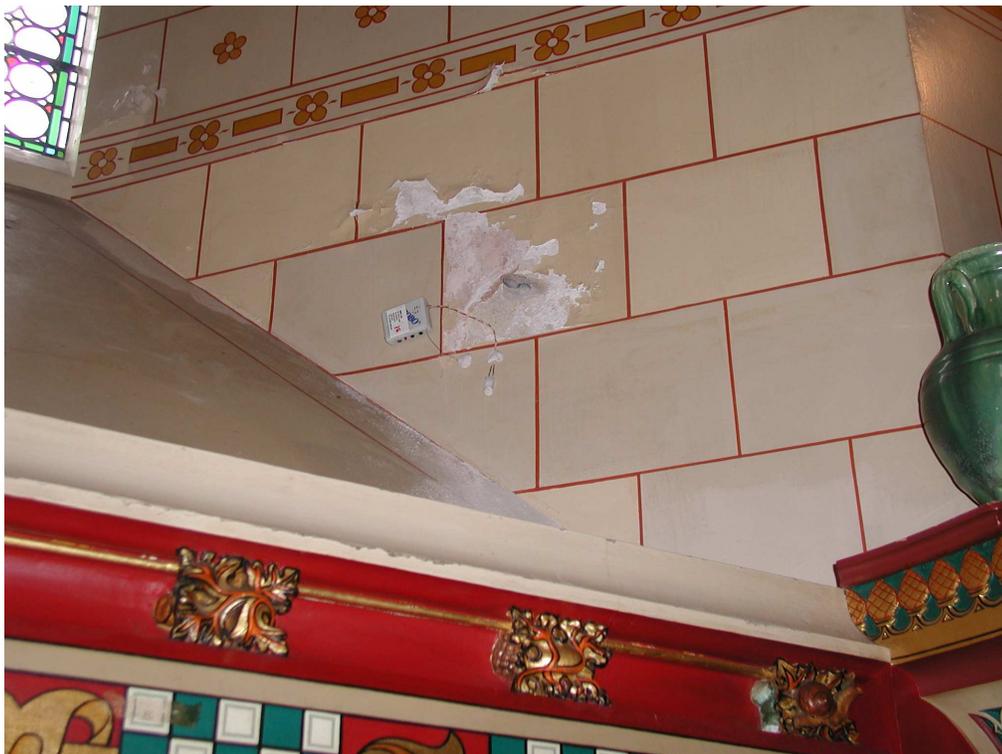
Photograph 3 Showing surface reading of environmental conditions

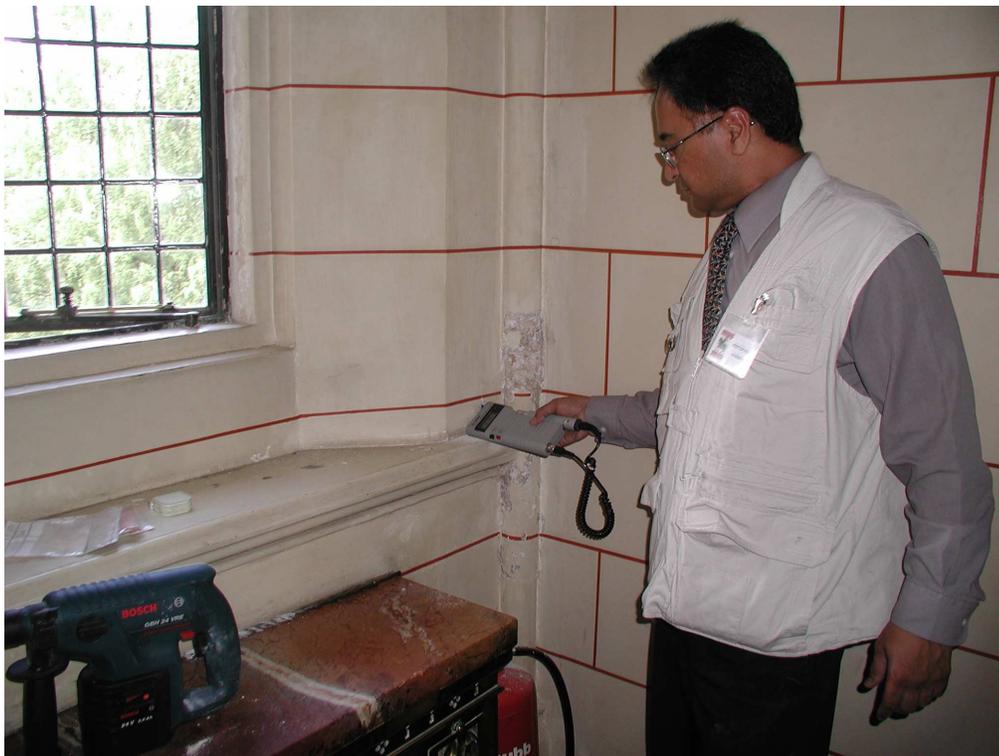
Photograph 4 Monitoring RH in wall void

The level of Humidity in a building can be a good indicator of potential building defects. This coupled to temperature measurement can enable condensation risk to be assessed.

For the measurement of relative humidity in concrete and masonry, sealed plugs are inserted to 40% of the depth of the masonry to be measured. After a minimum period of 10 hours the seal is broken and the relative humidity noted after a period of equilibrium has been reached.

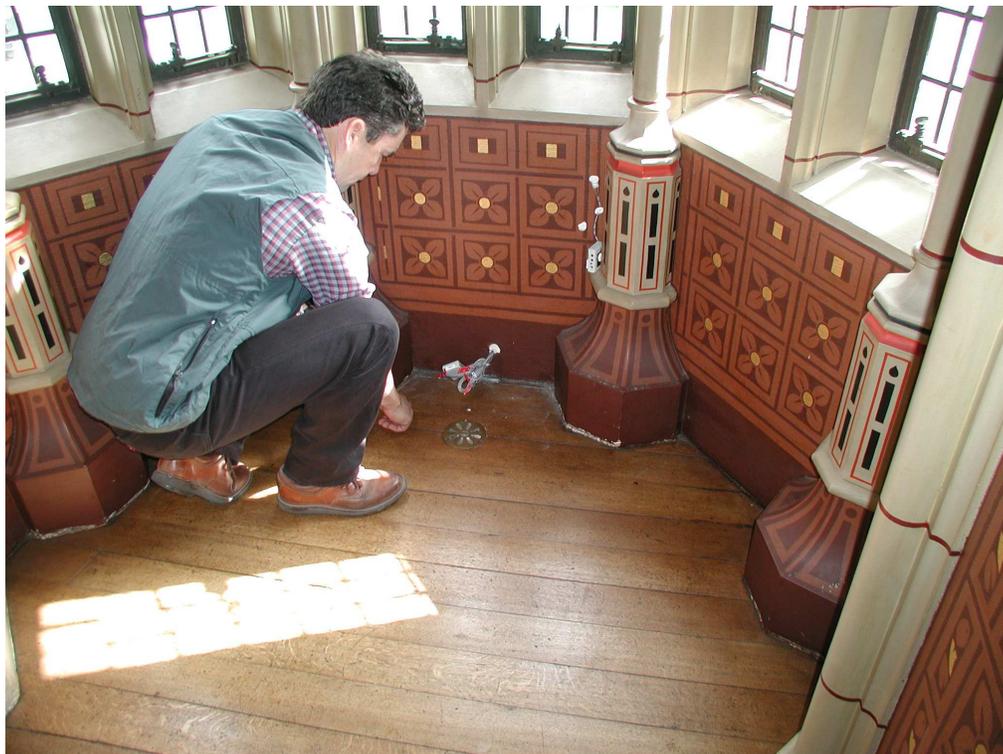
Photograph 5 Environmental monitoring at Cardiff Castle

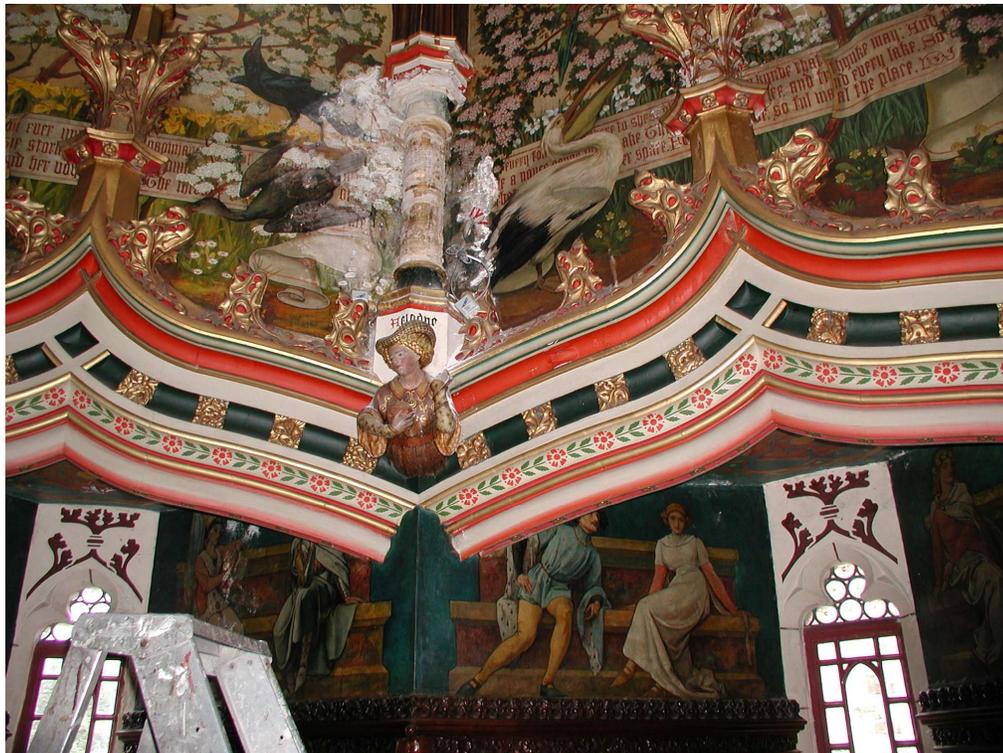
Photograph 6 Environmental monitoring at Cardiff Castle

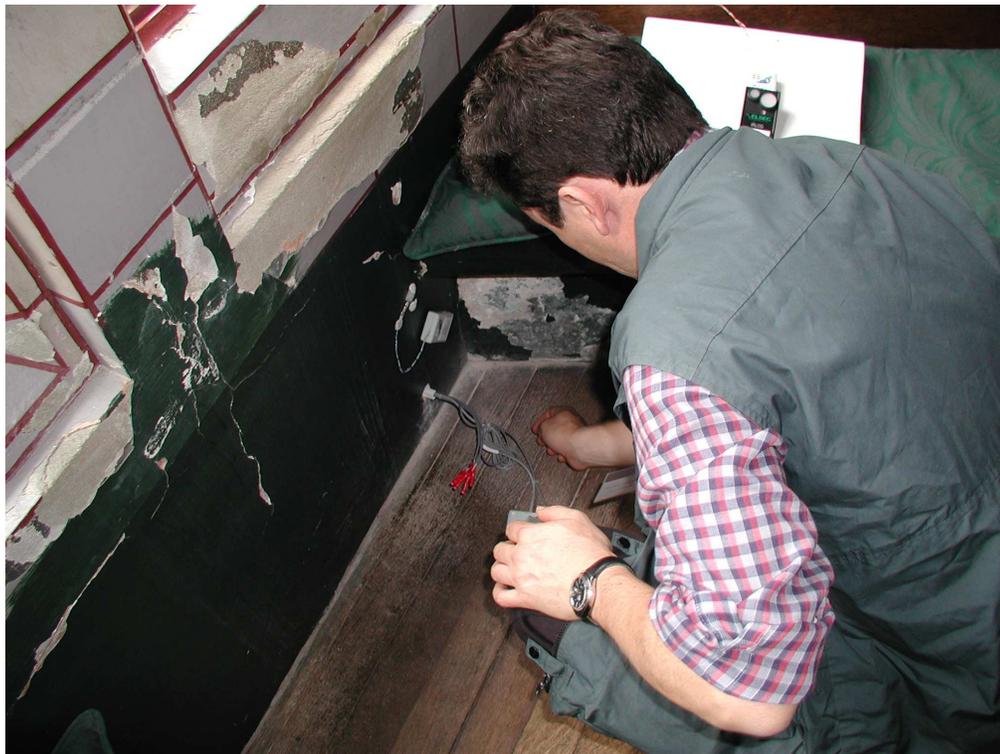
Photograph 7 Environmental monitoring with wall probes at Cardiff Castle

- Wall surface RH, temperature, Dew point and Vapour pressure and
- The temperature, RH, vapour pressure and Dew point within the masonry at varying depths.

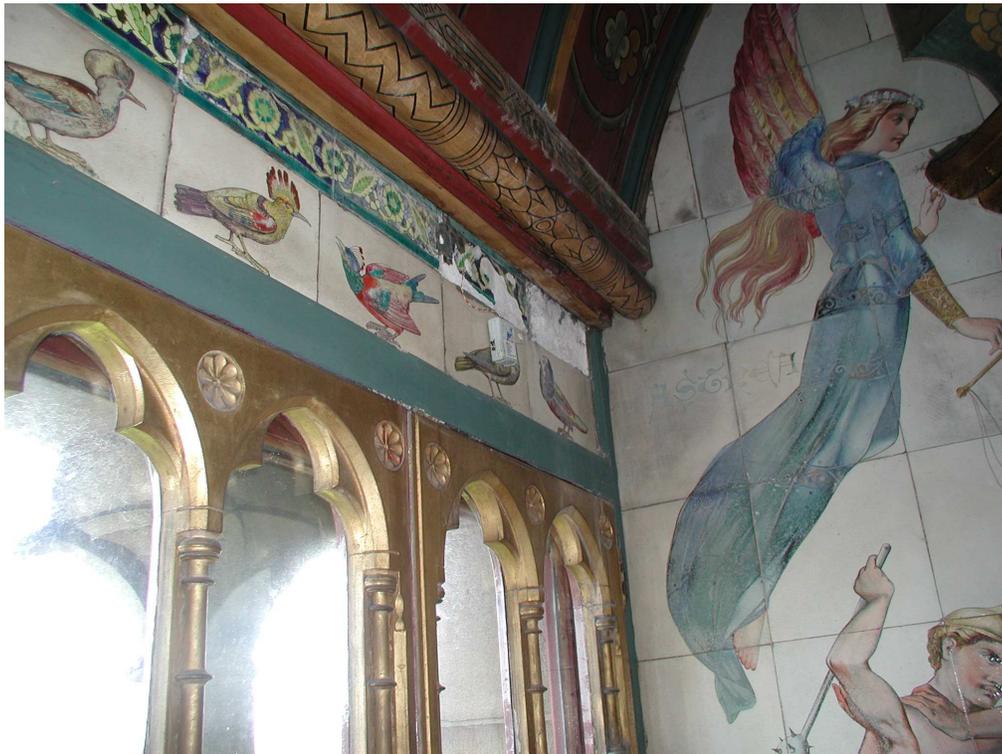
Photograph 8 Cardiff Castle showing deterioration to decorative finishes

These decorations were applied directly to the wall surfaces, some of which were now showing signs of water and salt damage.

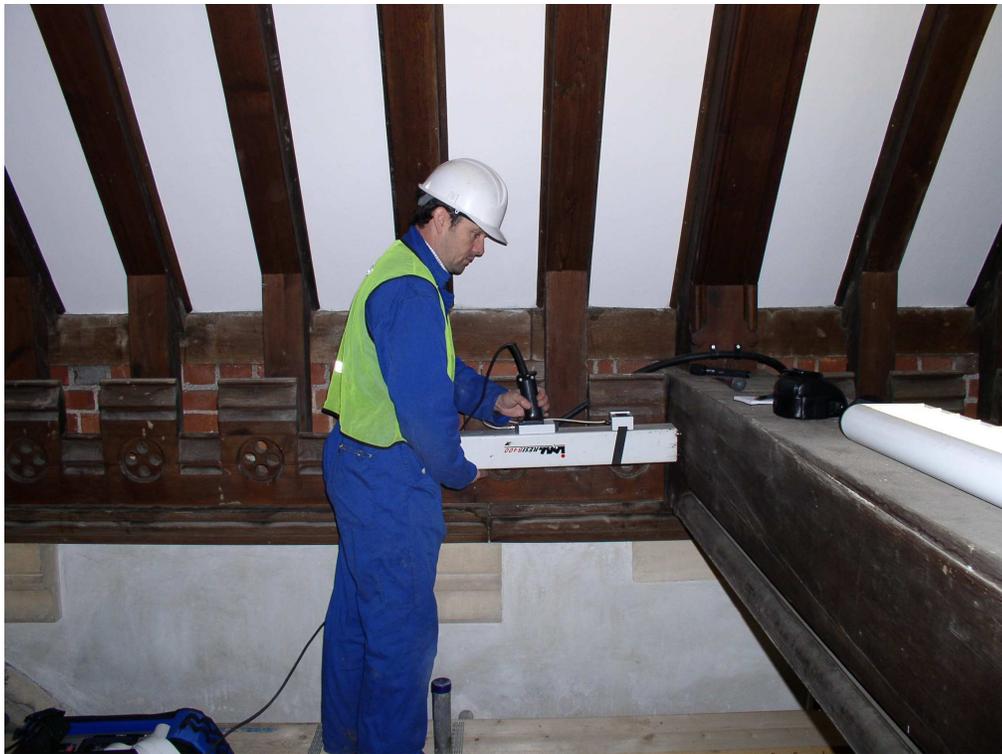
Photograph 9 Resistograph monitoring of timbers in a roof space.

Deterioration of structural timber elements is investigated with the use of non-destructive 'Resistograph' instrumentation.
